**Re: Cordova MDWCA, Minor, SIC 4952; NPDES Reconnaissance Inspection; Inspection Date:  
February 20, 2018**

**Cordova MDWCA**  
**NPDES Tracking No. NMU001962**  
**Reconnaissance Inspection (RI)**  
**February 20, 2018**

Attachment #1  
New Mexico Environment Department  
Ground Water Quality Bureau  
Inspection Report  
Dated: January 8, 2018

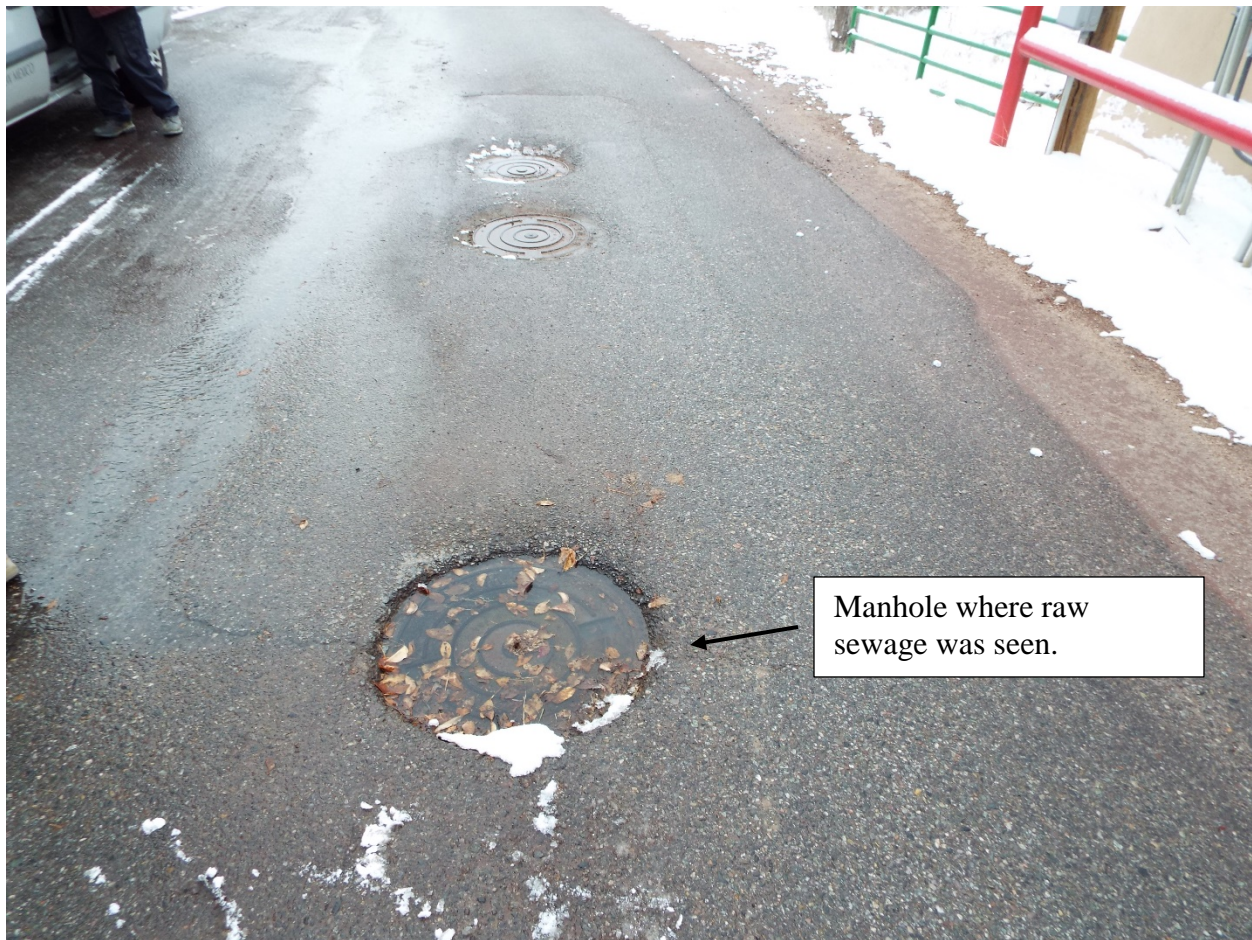
**NMED/ SWQB**  
**Official Photograph Log**  
Photo # 1

On this date, there was still snow on the ground, which was melting. However, you could smell the sewage and see the staining on the pavement where it had been trailing down to the Rio Quemado.

Photographer:	Date: February 20, 2018	Time: 10:00 AM
City/County: Cordova/Rio Arriba County		
Location: Cordova MDWCA (County Road 80)		
Subject: Manhole; raw sewage surfacing.

The representatives stated that they had no money to fix the leak and were awaiting to hear about any funding possibilities to help them fix the issue. After discussion about the possibility of enforcement from USEPA, the MDWCA fixed the raw sewage leak that same afternoon. They provided photos of the line where they replaced a 2" PVC elbow. This corrected the problem and there is no longer raw sewage entering the Rio Quemado.

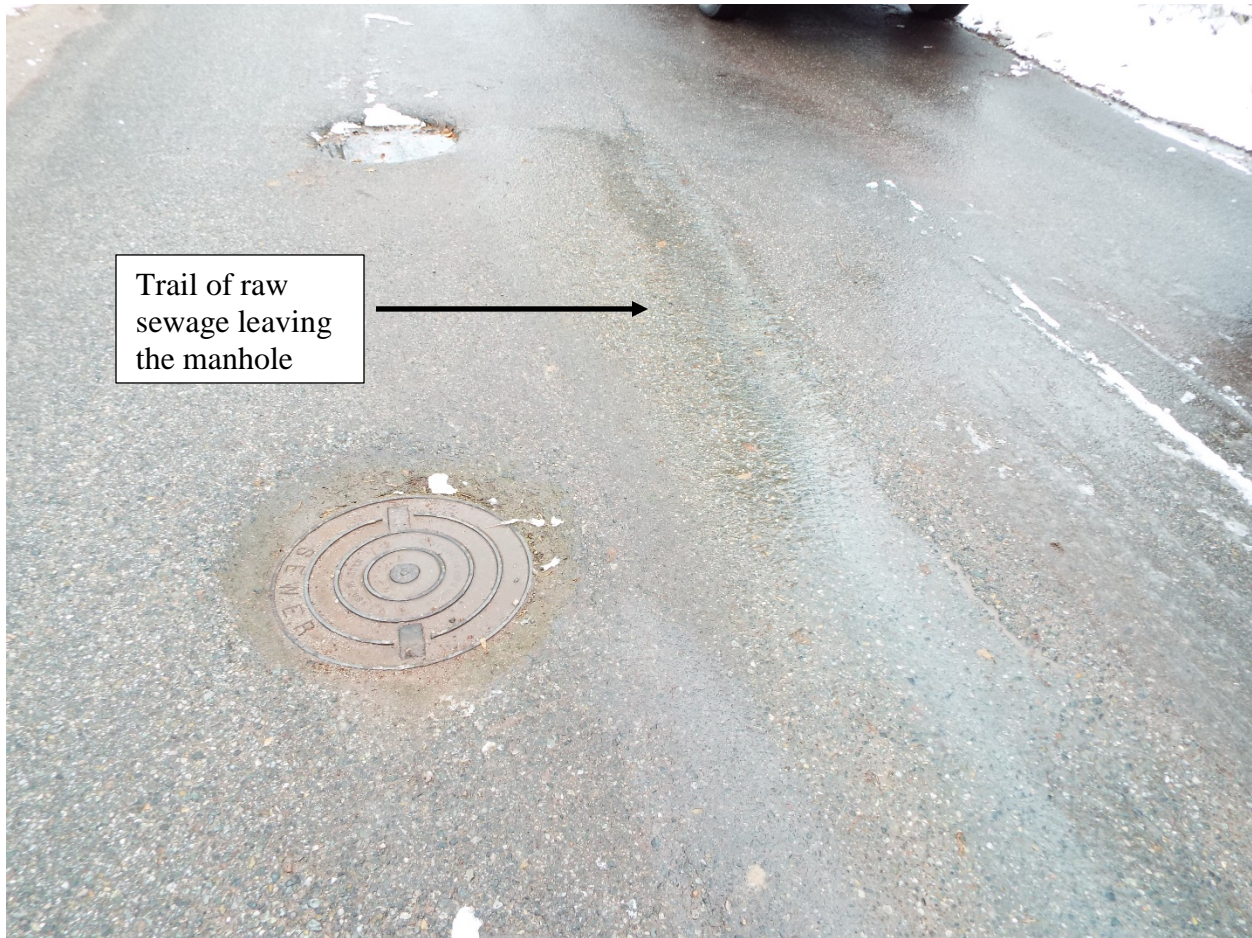
**NMED/SWQB**  
**Official Photograph Log**  
Photo #2

Photographer:	Date: February 20, 2018	Time: 10:00 AM
City/County: Cordova / Rio Arriba County		
Location: Cordova MDWCA		
Subject: Raw sewage trail leading to Rio Quemado

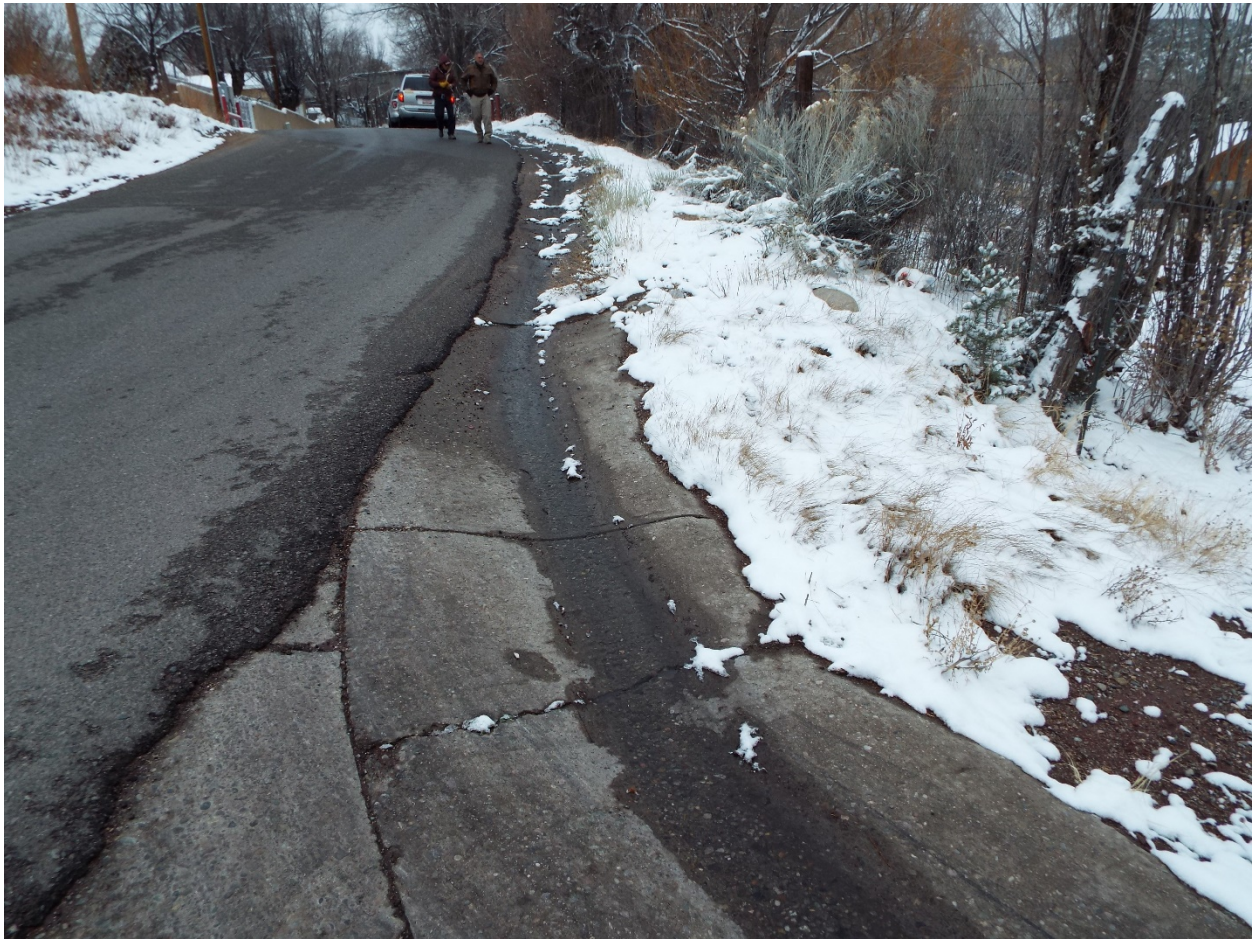
**NMED/SWQB**  
**Official Photograph Log**  
Photo #3

Photographer:	Date: February 20, 2018	Time: 10:02 AM
City/County: Cordova / Rio Arriba County		
Location: Cordova MDWCA		
Subject: Raw sewage commingled with melting snow.

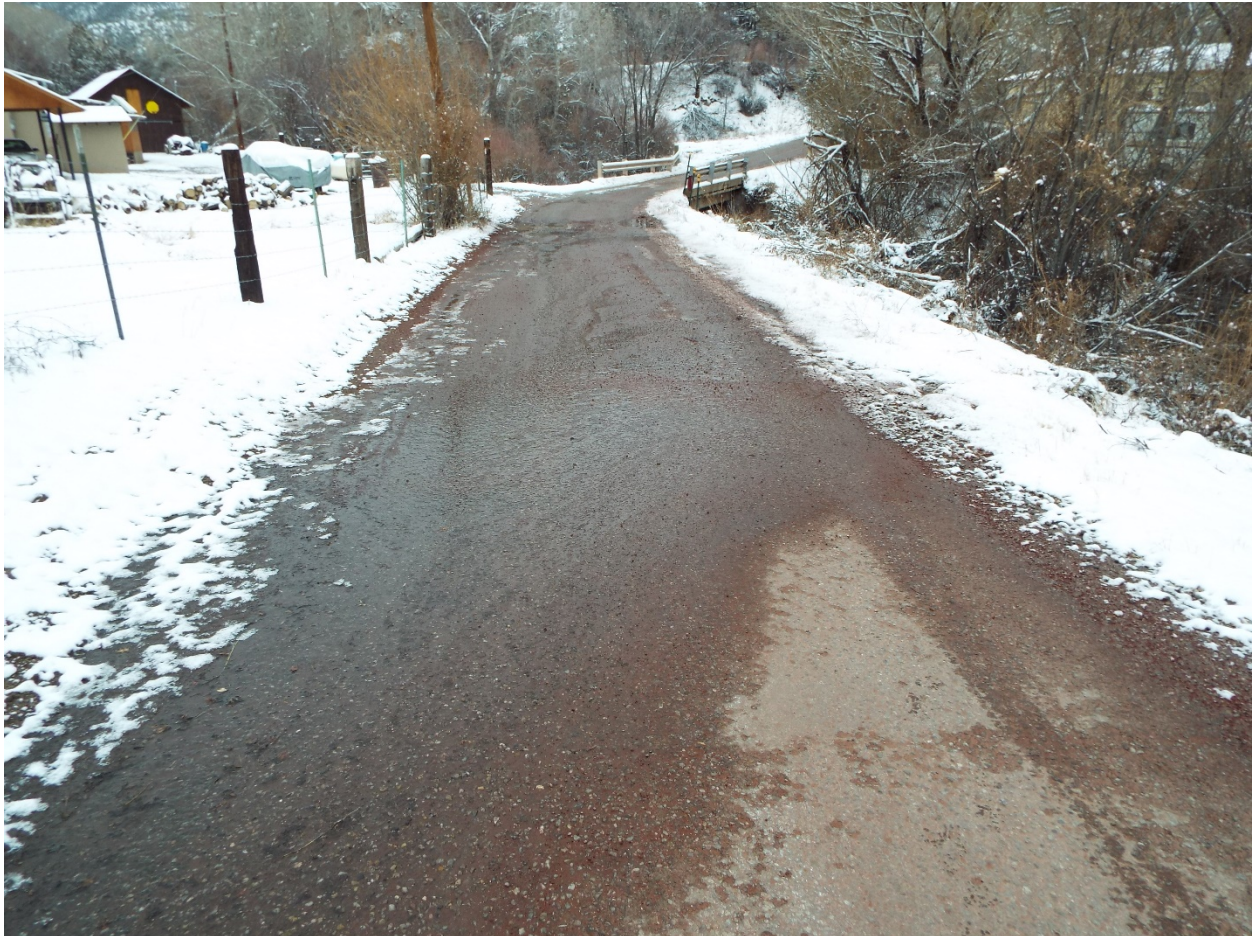
**NMED/SWQB**  
**Official Photograph Log**  
Photo #4

Photographer:	Date: February 20, 2018	Time: 10:02 AM
City/County: Cordova / Rio Arriba County		
Location: Cordova MDWCA		
Subject: Raw sewage commingled with melting snow.

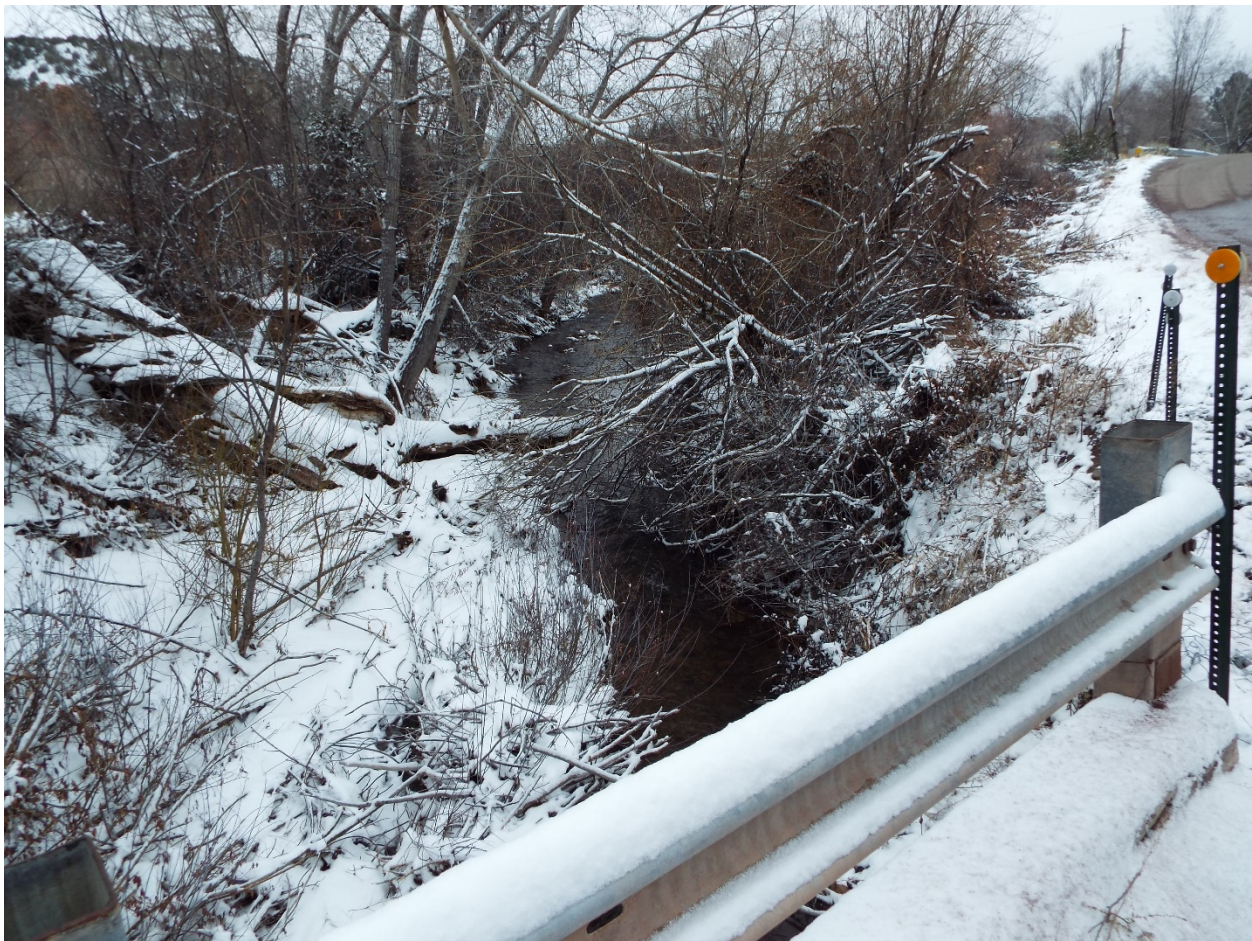
**NMED/SWQB**  
**Official Photograph Log**  
Photo #5

Photographer:	Date: February 20, 2018	Time: 10:04 AM
City/County: Cordova / Rio Arriba County		
Location: Cordova MDWCA		
Subject: Rio Quemado

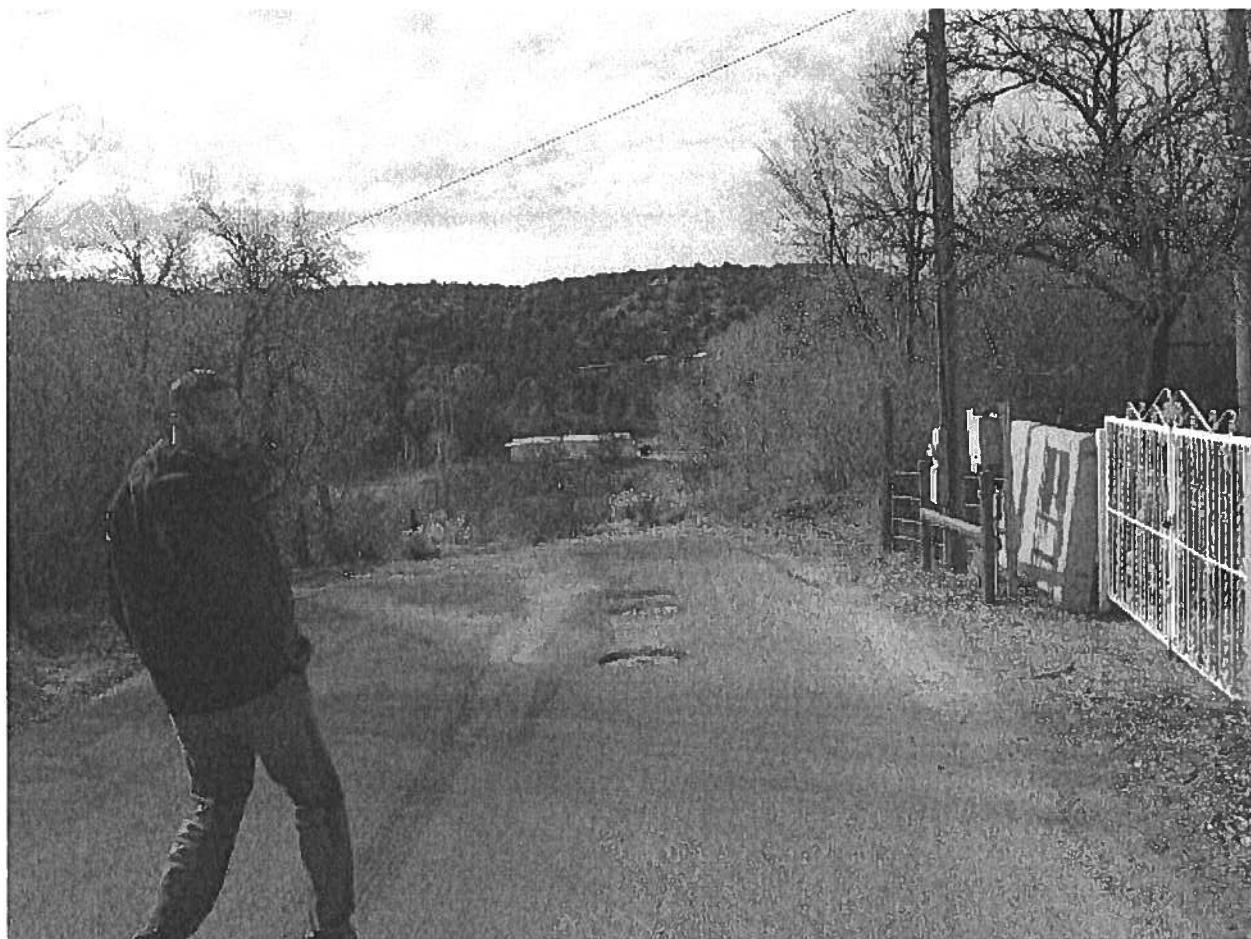
*Figure 2: POER FOR THE LIFT STATION.*

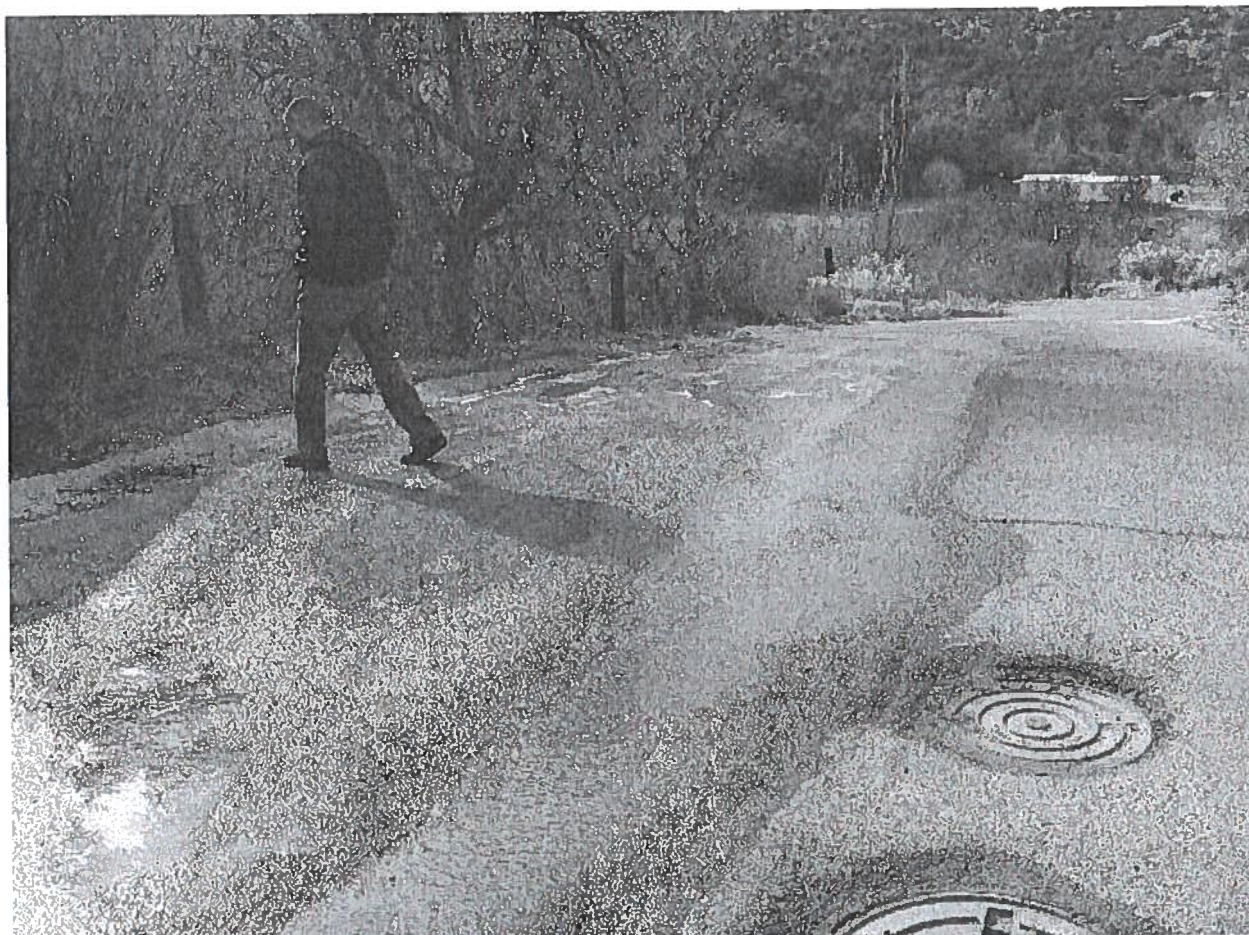
*Figure 3: LEAKING AREA AND POWER INSTALLATION.*

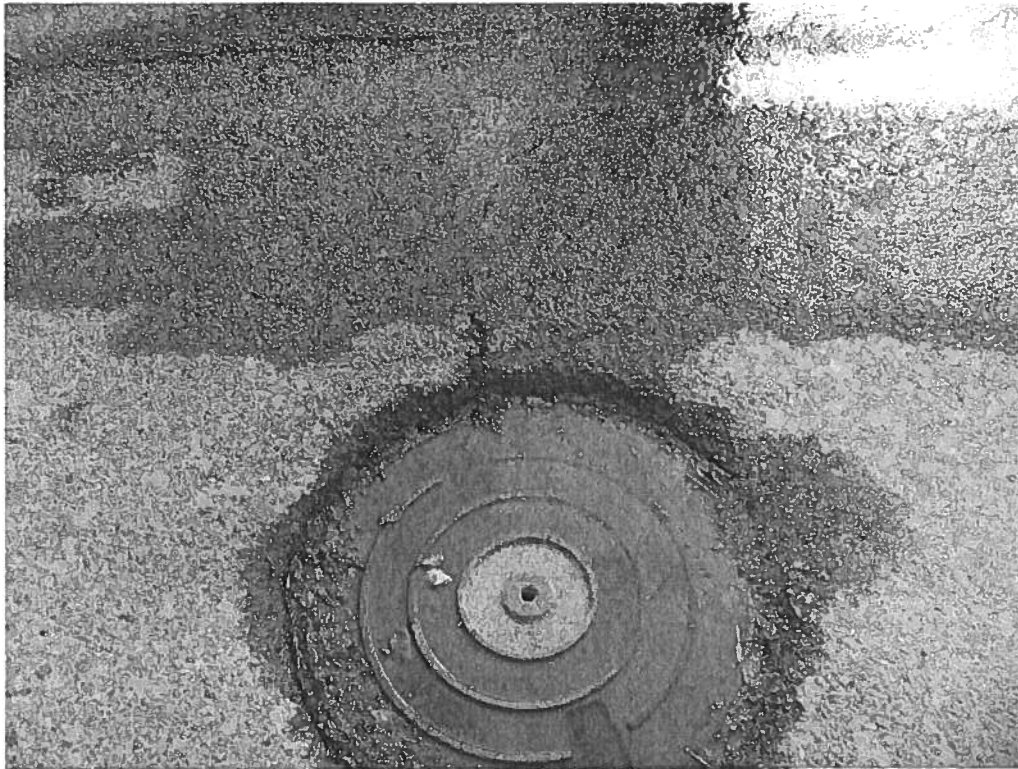
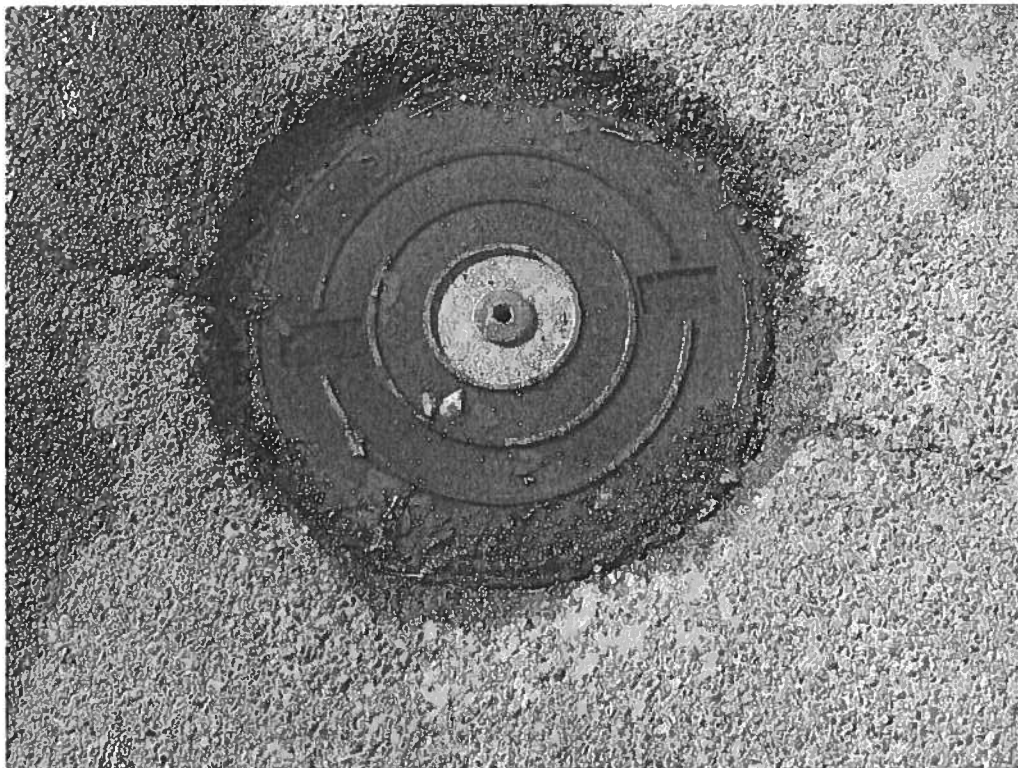
*Figure 4: LEAKING AREA AND ICY AREA AS A RESULT.*

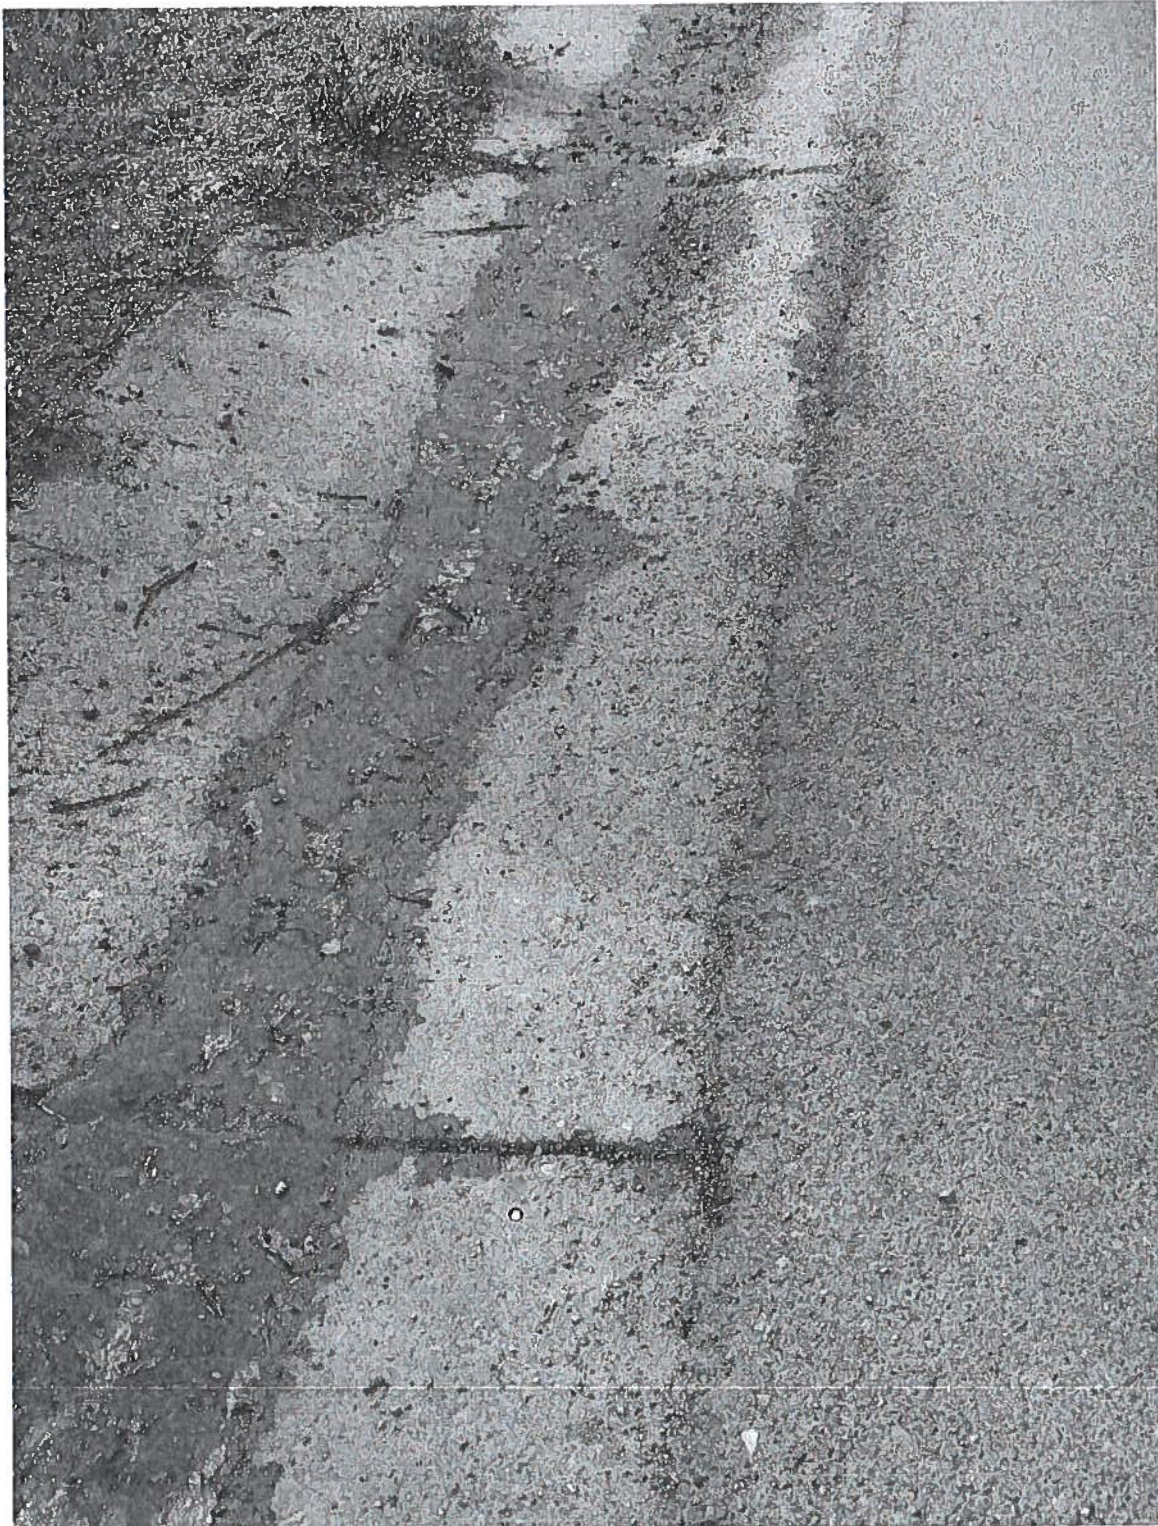
NMED staff met with the Association Board Member. Leaking from the area of the furthest uphill manhole cover continues. While there was no odor (temperature about 45° F), it appeared to be wastewater. We arrived at appeared to be the end of a pumping cycle, so the amount of flow was minimal (~ 1 gpm) some of which seemed to be coming up through the pavement. It is possible that most of the discharge occurs during pumping but that the leaking continues after the pump is off by wastewater in the force main flowing back from the higher elevation and exiting at some crack in the force main near the manhole. The flow freezes on the roadway and creates a road hazard. It also flows downhill and, when observed at the time of the inspection, a small amount reaches the stream at the base of the hill.

*Figure 5: LEAKAGE FROM FURTHEST UP HILL MANHOLE.*

It is most likely that the only way the problem will be attended to is through an enforcement action which would be as much an aid to help in securing some funds. The first requirement is to diagnose the problem through inspecting the area of the leak and this might be done by video camera in the force main.

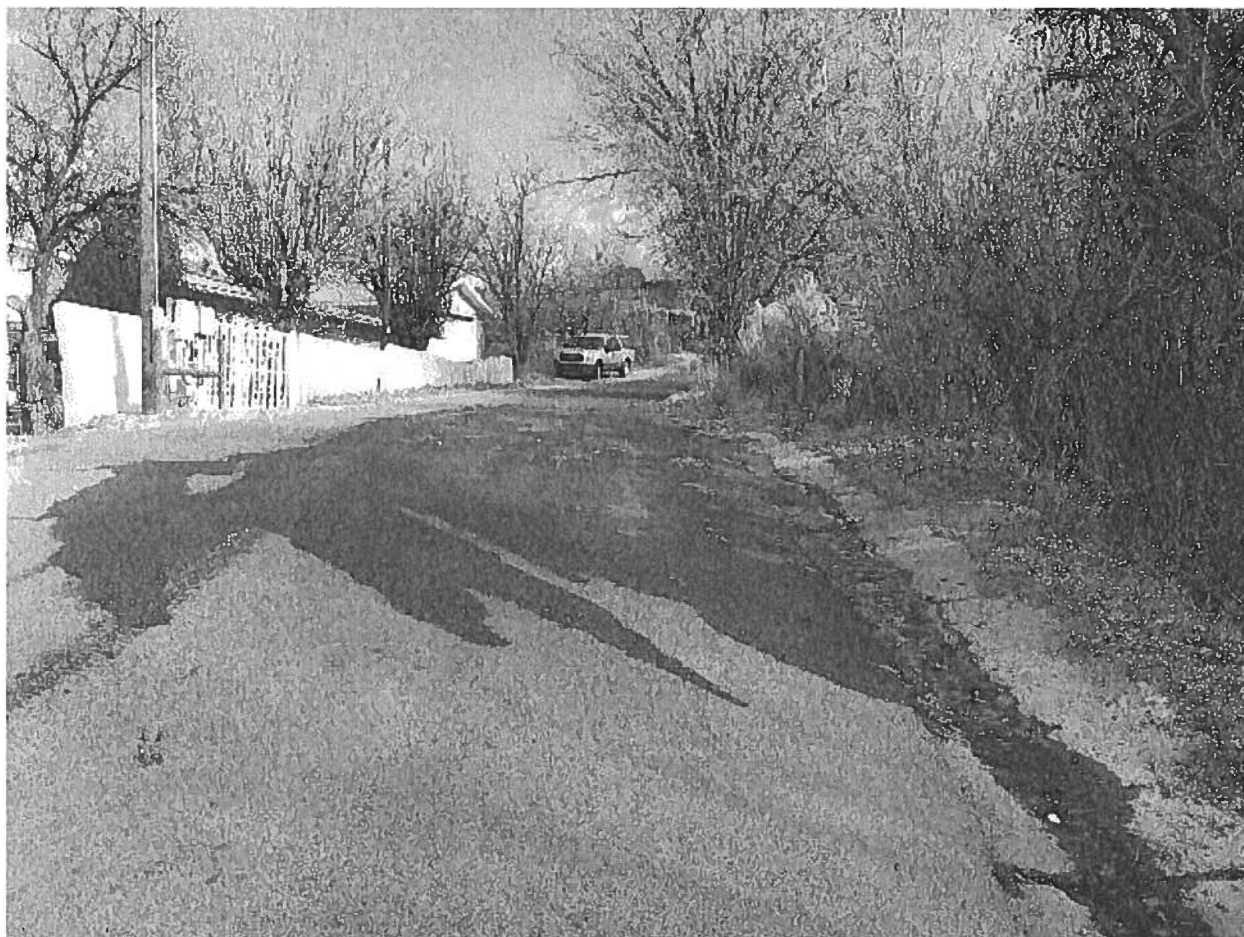
*Figure 6: LEAKAGE FLOWING DOWNHILL TOWARDS THE STREAM.*

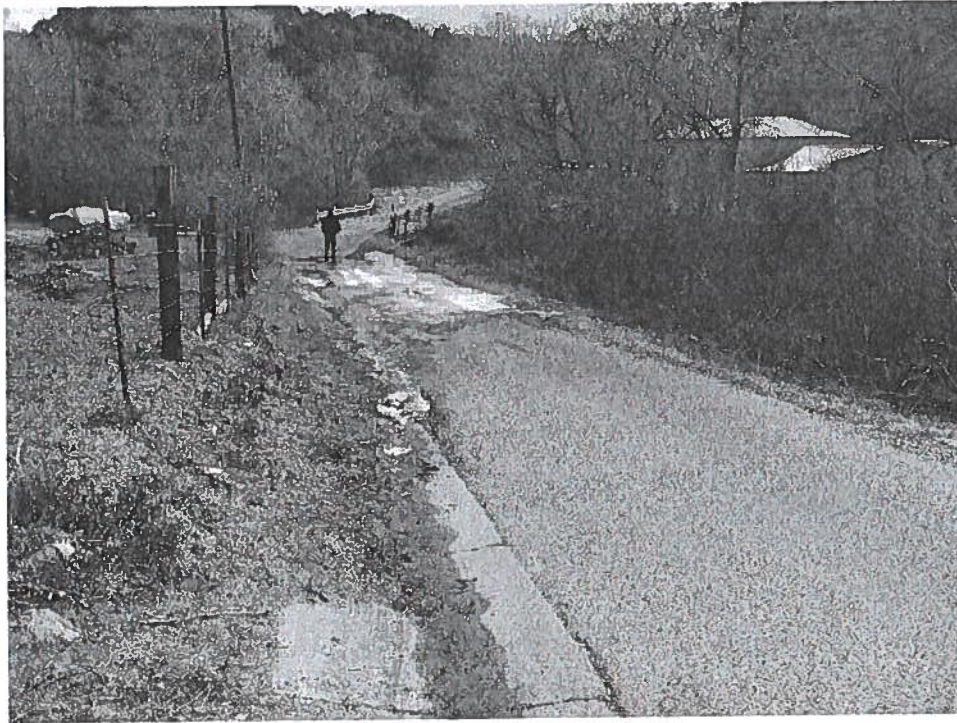
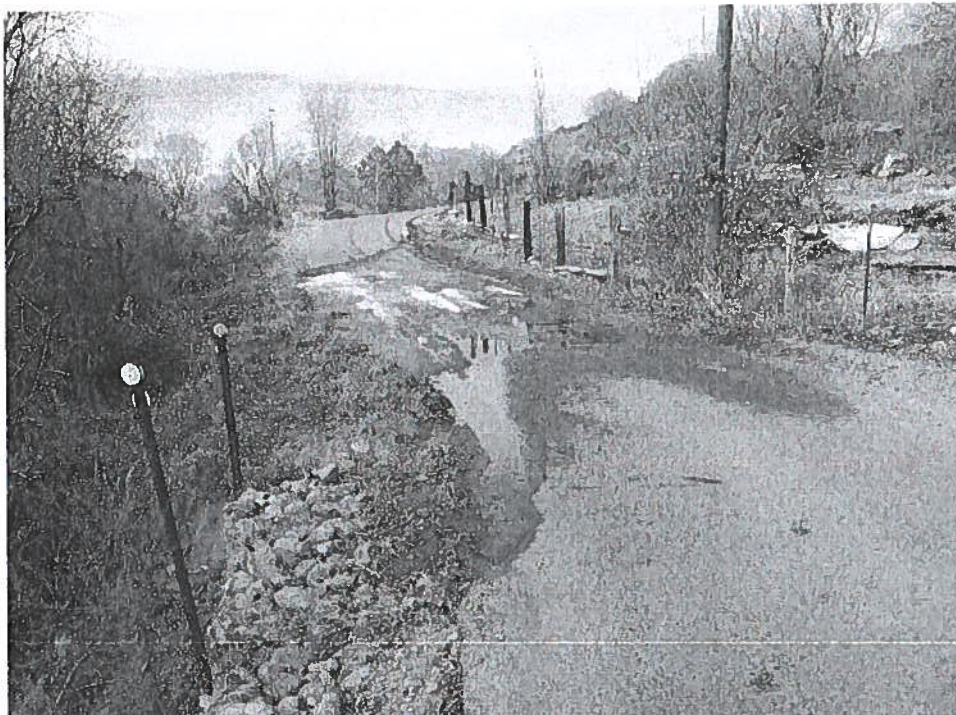
*Figure 7: FULLER VIEW OF DRAINAGE FROM LEAK.*

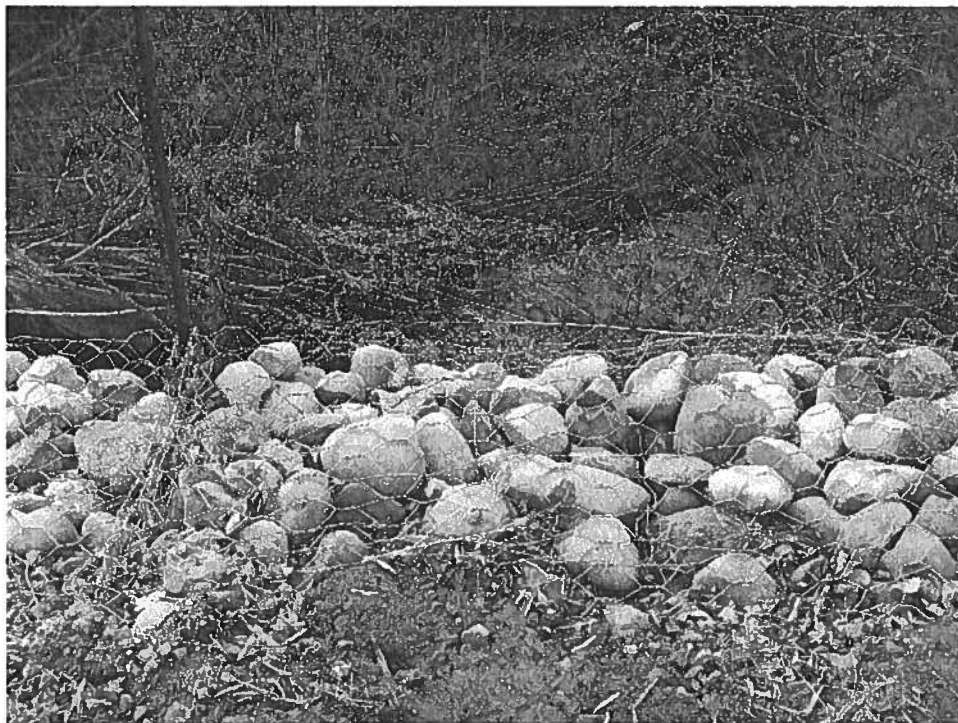
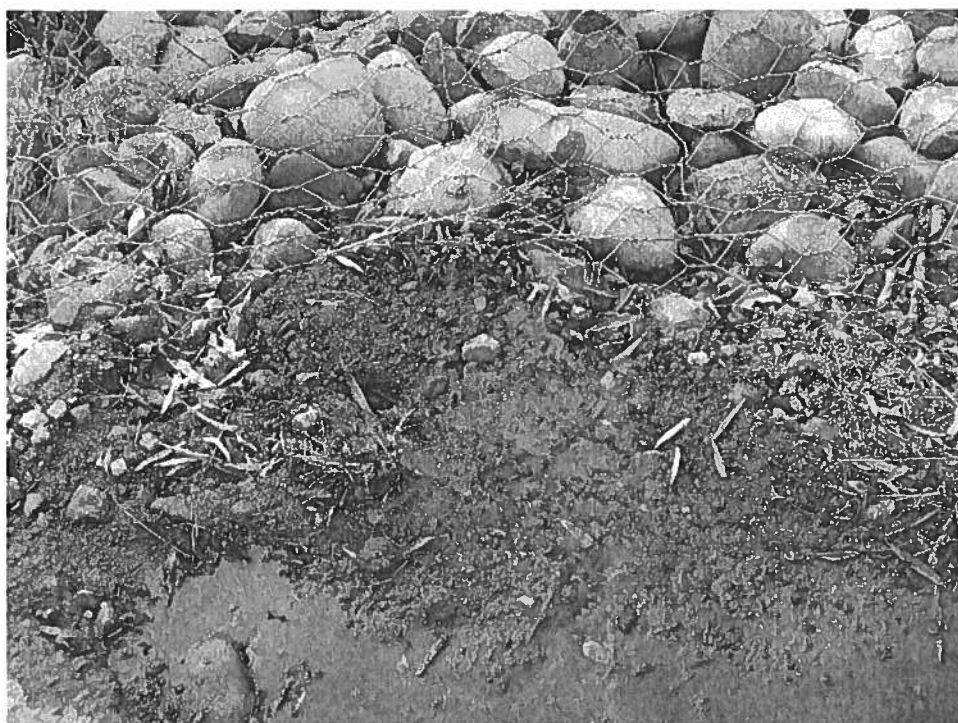
*Figure 8: ICE FROM LEAKAGE AND FLOW OVER ROADWAY TO STREAM.*

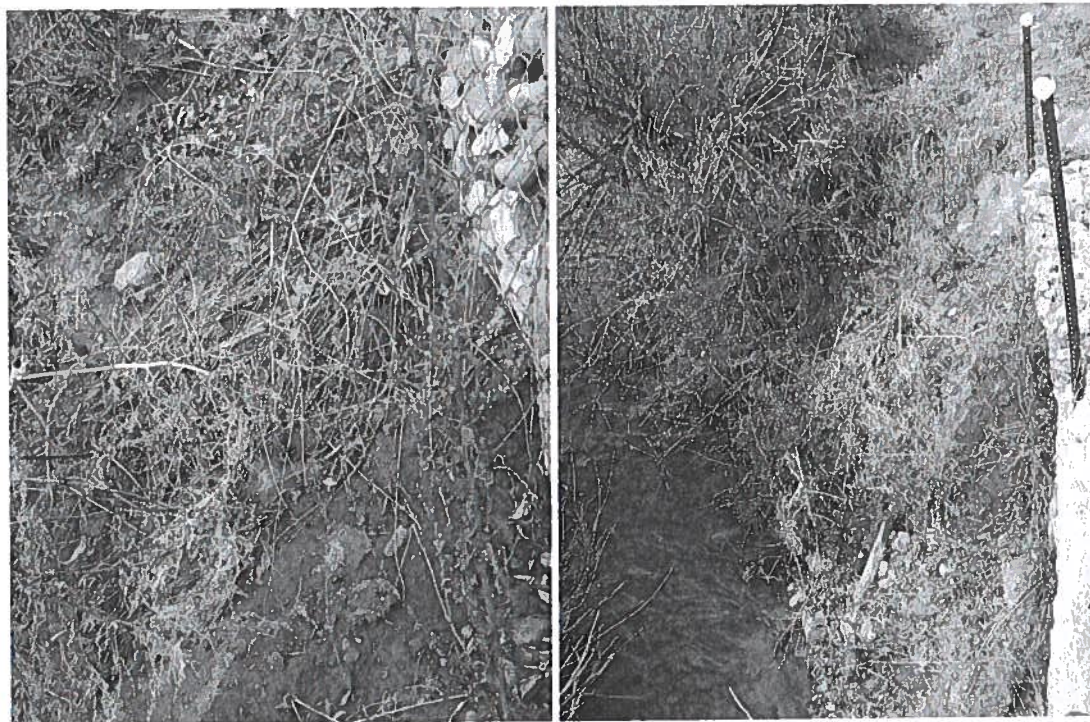
*Figure 9: FLOW JUST BEFORE GOING OVER THE EDGE TO THE STREAM.*

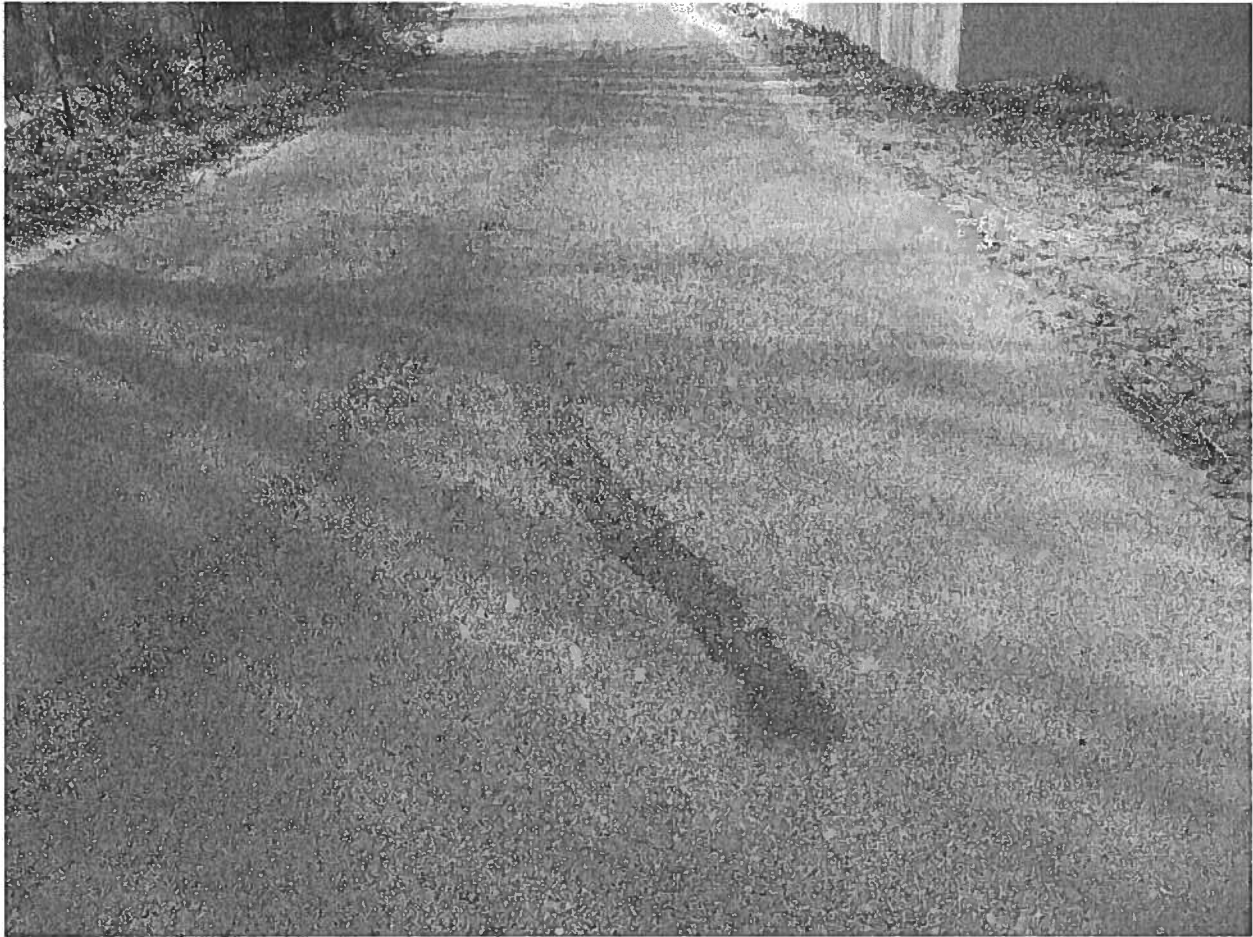
*Figure 10: FLOW GOING OVER THE EDGE OF THE ROADWAY WITH SOME REACHING THE STREAM.*
